PARKS COLL OF SAINT LOUIS UNIV CAHOKIA ILL
SHOCK PULSE METER ANALYSIS.(U)

SHOCK PULSE METER ANALYSIS

15 OCTOBER 1974

FINAL REPORT

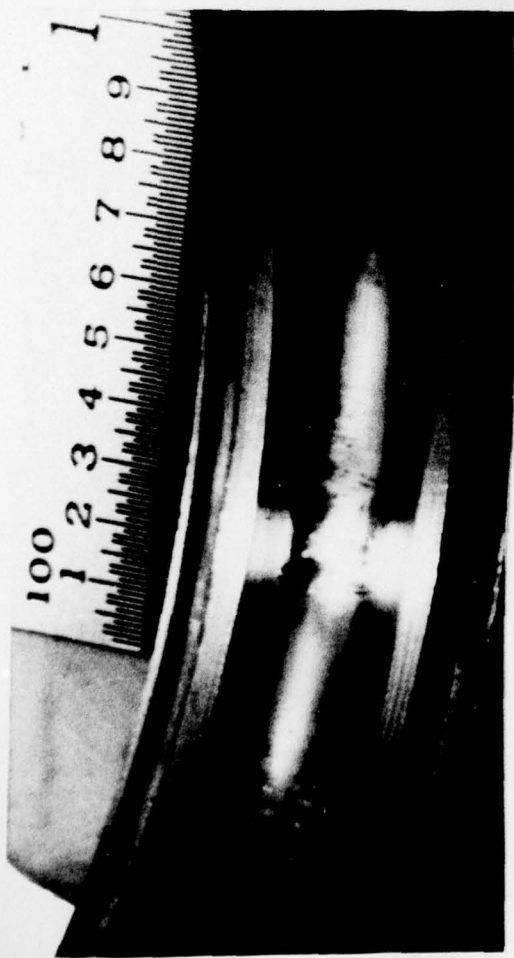
Hanger Bearing
 S/N A20-36705
 A/C 63-8784

The four hanger bearings which were removed for analysis all yielded teardown data clearly showing damage. When compared with Bell Helicopter's damage condition category definitions, we would consider between C and D defects on all assemblies. Hanger bearing A20-31435 had the heaviest concentration of corrosion and pitting on the outer race as well as the rolling elements and its shock pulse data shows the highest level of the assemblies tested. Hanger bearing A20-44891 exhibited the highest rate monitored on a hanger bearing assembly and coupled with its shock level of 700, it fit in a category of damage which became evident at teardown. No statements as to the time to complete functional failure of the hanger bearing assemblies can be made; however, we feel that the damage found at teardown would contribute significantly to a decrease in efficiency of the assembly.

REMARKS: Inner Race: Mild Corrosion
Outer Race: Pitting and Corrosion
Rolling Elements: Corrosion, Mild Pitting

REMARKS: Outer Race: Metal Fatigue, Pitting, Flaking Corrosion
Inner Race: Corrosion, Pitting
Rolling Elements: Corrosion, Pitting

REMARKS: Inner Race: Light Corrosion
Balls: Light Corrosion, Evidence of Skidding, Some Pitting
Outer Race: Corrosion, Pitting, Evidence of Skidding

REMARKS: Inner Race: Medium Corrosion, 1 Large Pit
Balls: Light to Medium Corrosion
Outer Race: Heavy Corrosion and Pitting

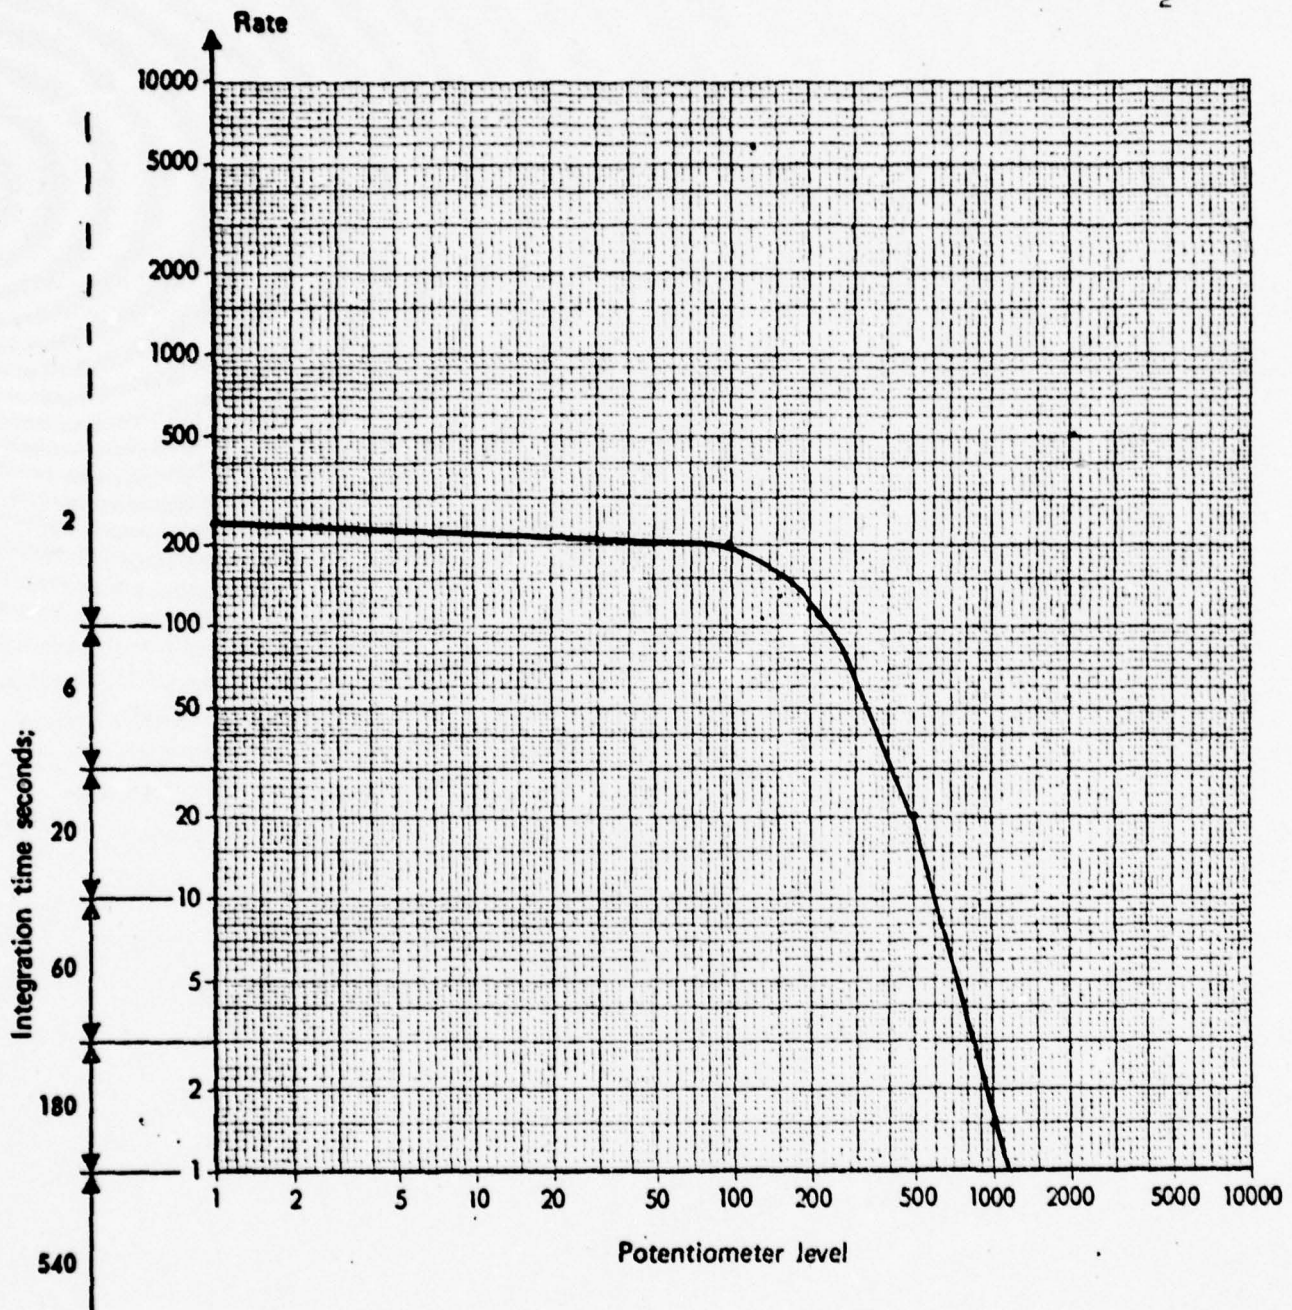
Figure 2

#1 Hanger Bearing
SN A20-55389

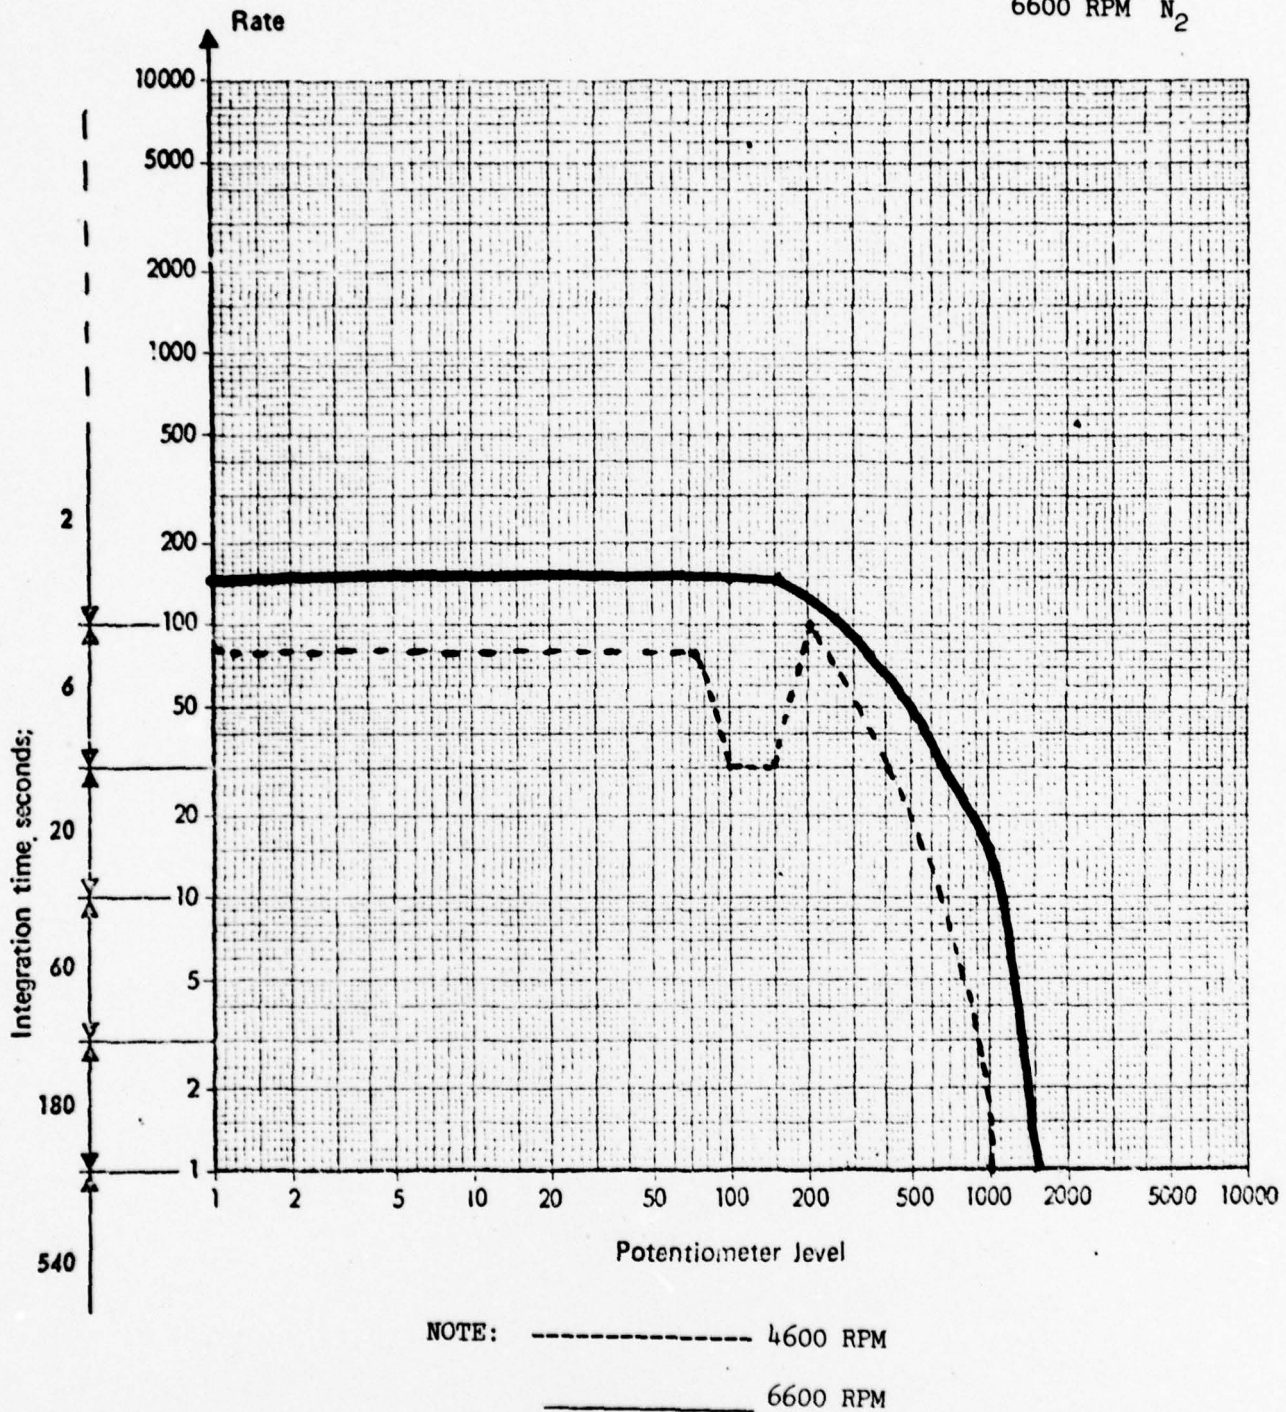
Figure 3

SN A20-36705

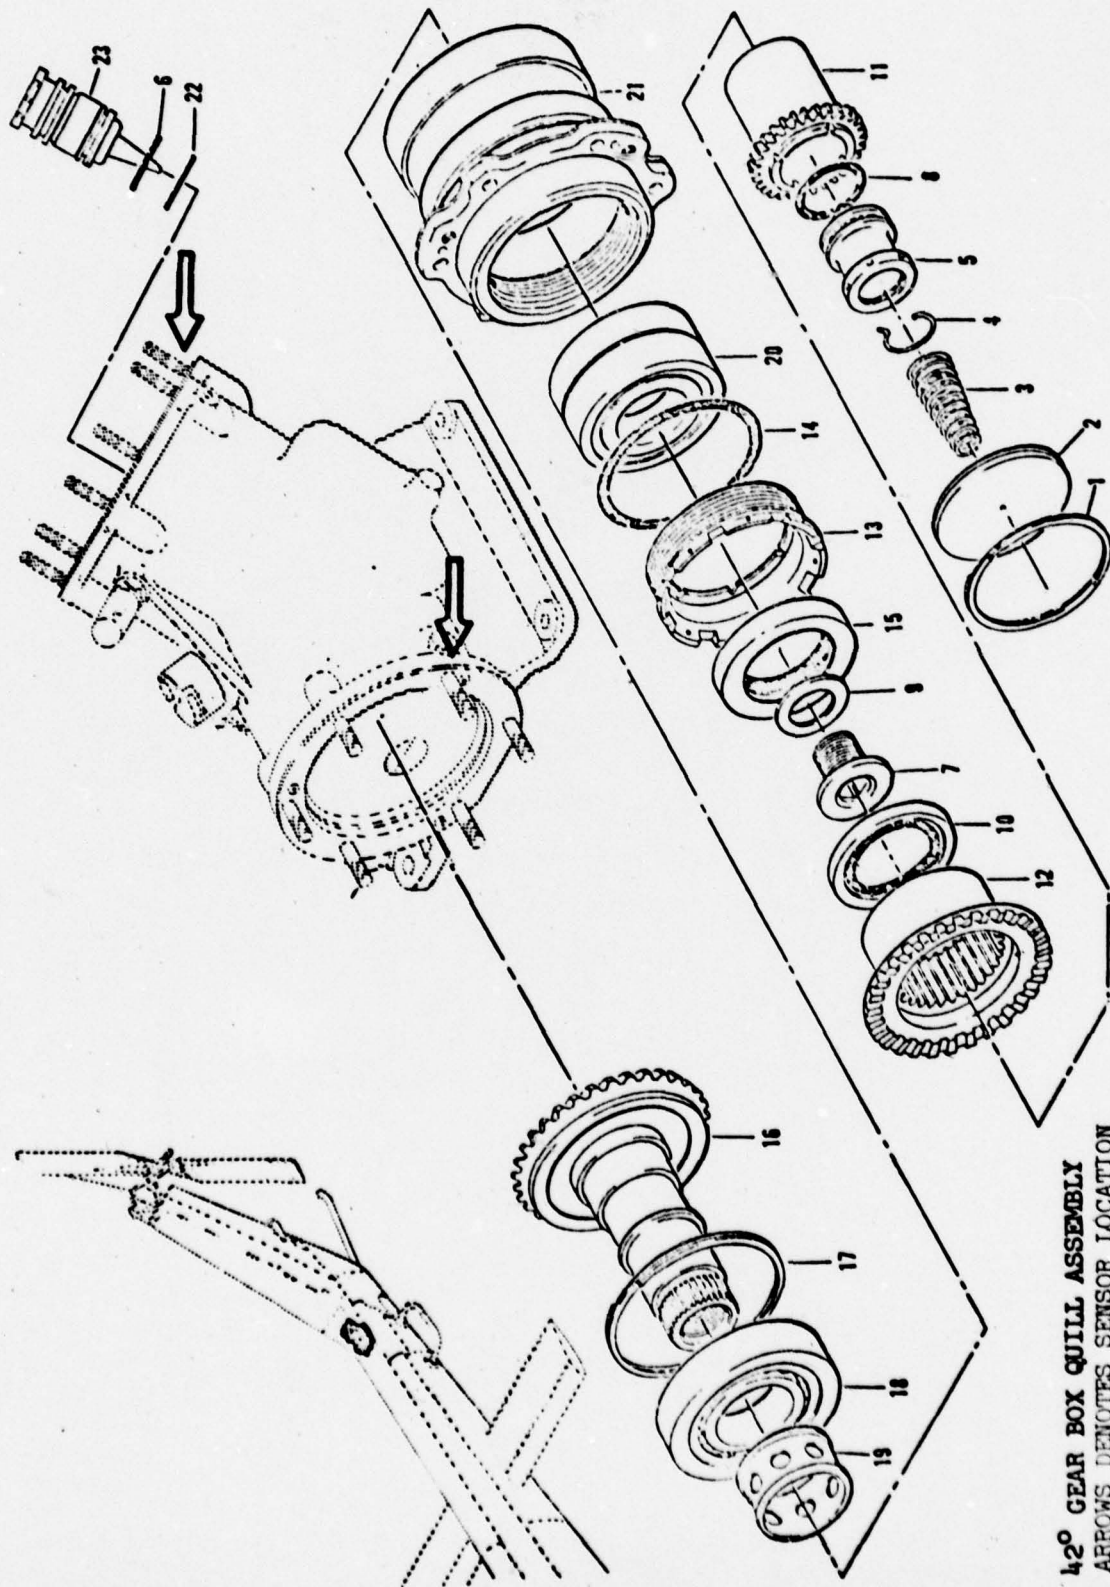
Figure 6

42° GEAR BOX QUILL ASSEMBLY
ARROWS DENOTES SENSOR LOCATION

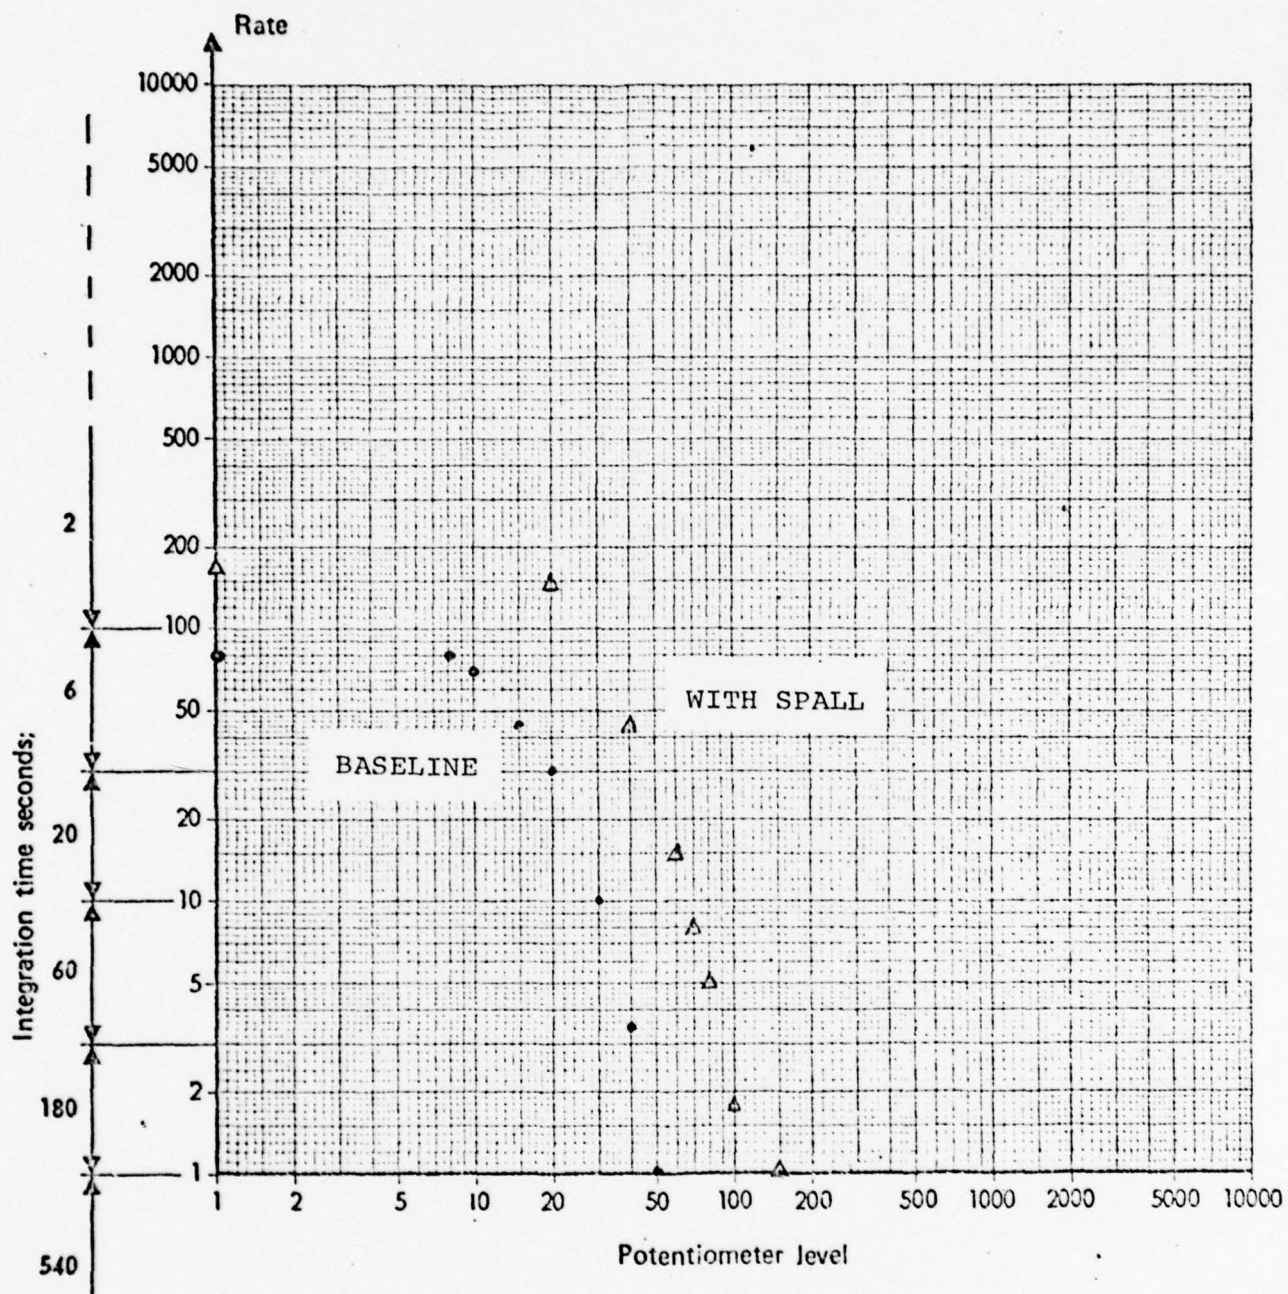
Figure 11 shows the shock pulse curve for the "sanitized" gear box as well as one with an implanted duplex bearing. In this case, the outboard half of the duplex bearing had a single spall in the outer race, 0.14" x 0.14", with a definite depth; the inboard half had some corrosion caused pitting with one pit in the ball's path. This damage was classified in category C which corresponds to moderate spalling.

COMPARISON OF BASELINE AND
DEGRADED GEARBOX (IMPLANTED
WITH SPALLED DUPLEX BEARING)

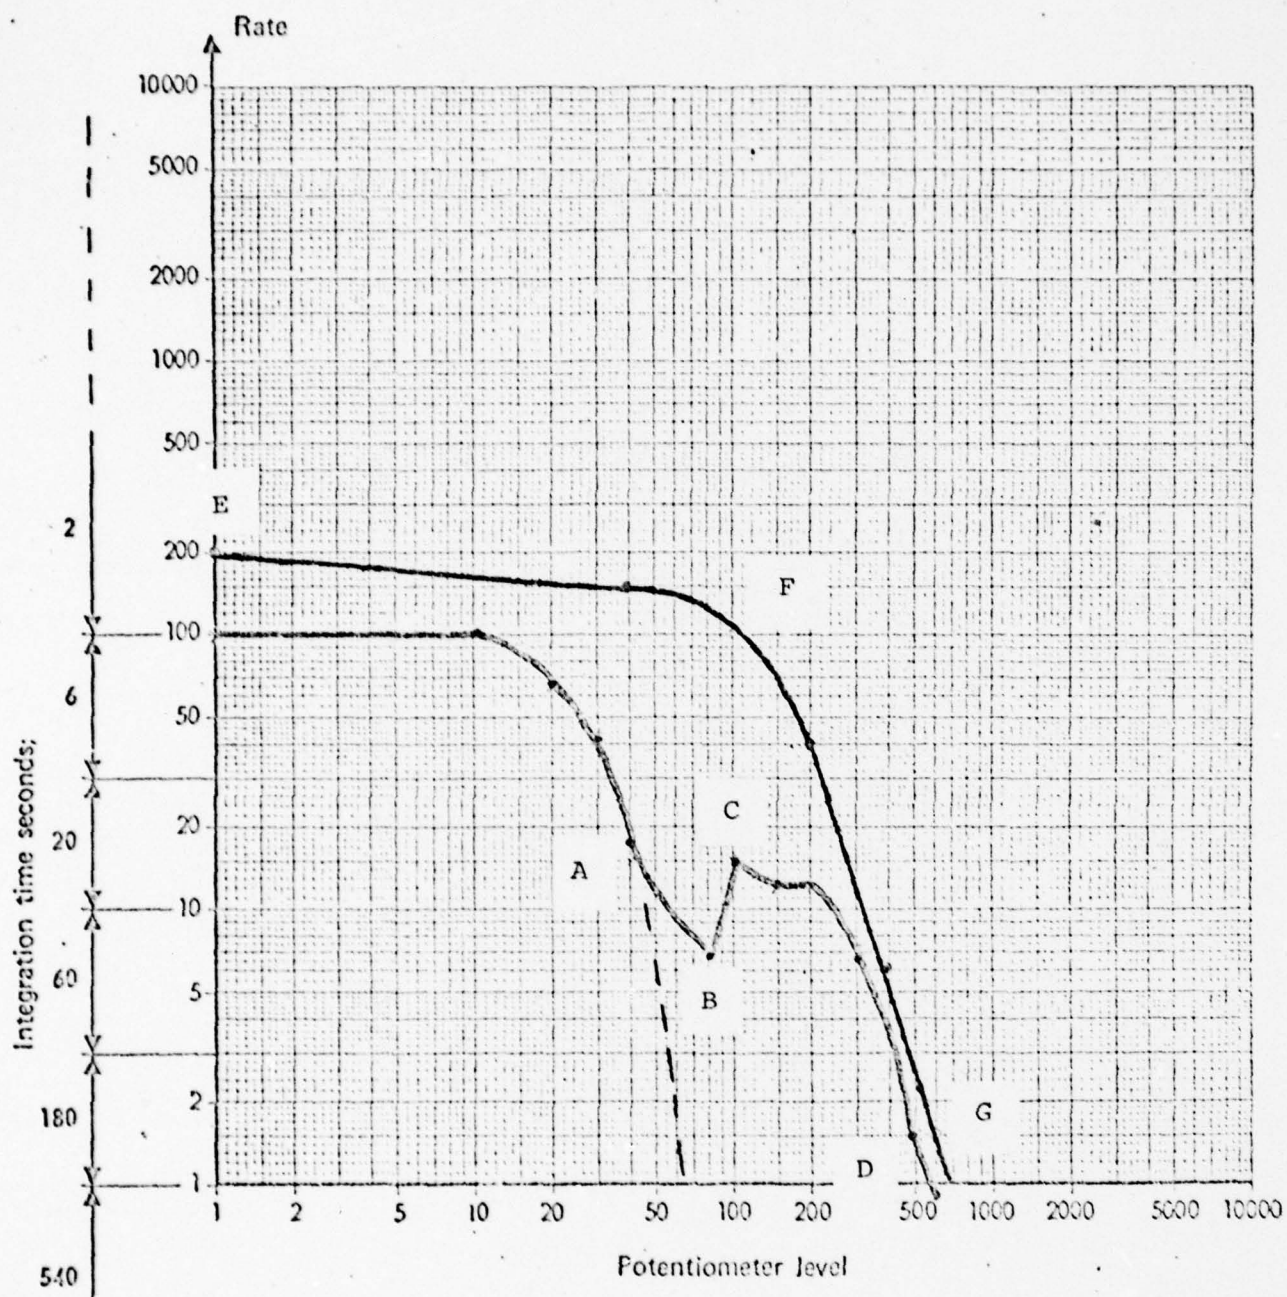
A second duplex ball bearing, this one with a single shallow spall approximately 0.08" x 0.08" in the outer race, was implanted in another 42° gearbox. Of particular interest was the observation of progressive damage while the test was in progress. The shape of the shock emission curve changed continuously over a period of minutes in both rate and shock level. Figure 12 shows two curves developed on a single run. A change in slope takes place (A), a sharp increase in rate (B-C), a continually change in slope (C-D). Without shutting down the engine, the second curve (E-F-G) was developed. After engine shut-down, an oil sample analysis revealed traces of metal, although not beyond that deemed unacceptable. The dotted line is an extrapolation of the initial slope and gives an indication of the shock level stabilizing at a factor of ten higher. Two more runs were made which essentially repeated curve E-F-G. Teardown analysis showed that the original degradation had not changed noticeably but that new spalls were found on the outer race and on one ball bearing.

42° GEARBOX IMPLANTED WITH A SPALLED DUPLEX BALL BEARING

EVIDENCE OF DAMAGE PROGRESSING

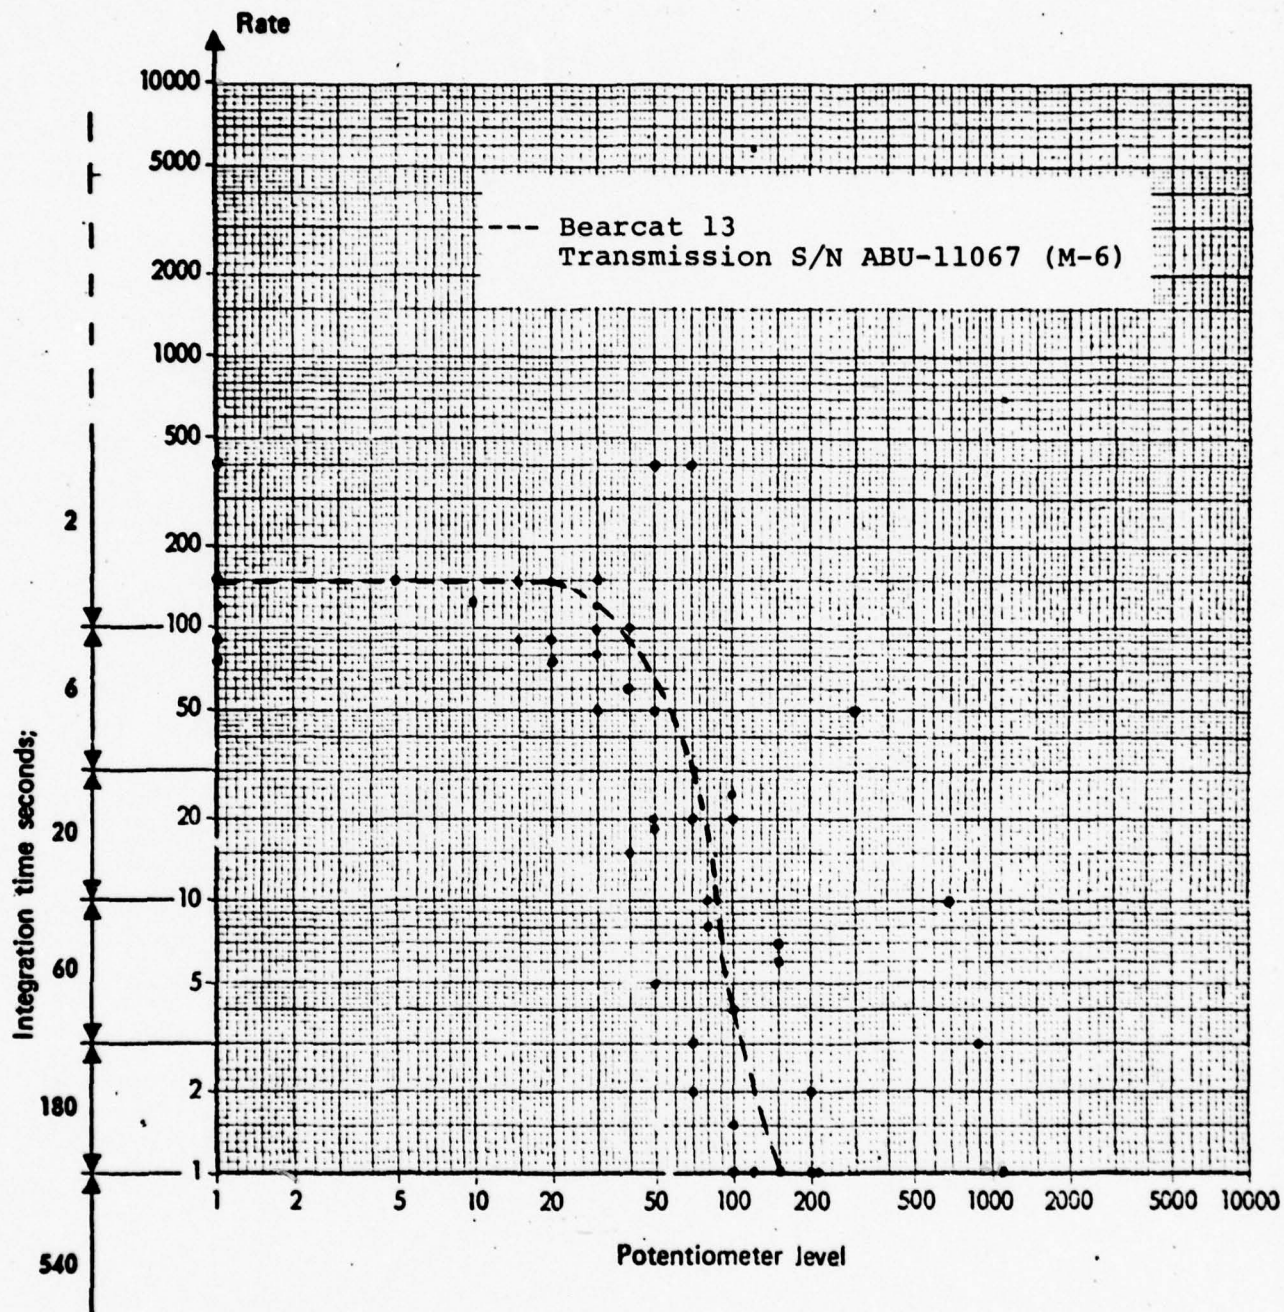
Shock pulse data was collected from two locations on the transmission. Figures 14 and 15 show the attachment point for the transmission input drive quill and for the mast bearing assembly. Figure 16 is a scatter diagram of nine different transmissions with the accelerometer attached to the input drive quill. The dotted line is that recorded from Bearcat 13 at Fort Rucker, Alabama. This is the only transmission of known good condition, having been inspected prior to its use in the AIDAPS program. One of the transmissions installed on UH-1C 66-15071 indicates a much higher rate and level than the others.

Scatter Diagram
Transmission Input Drive Quill;
Ground Runs, N_2 = 6600 RPM.

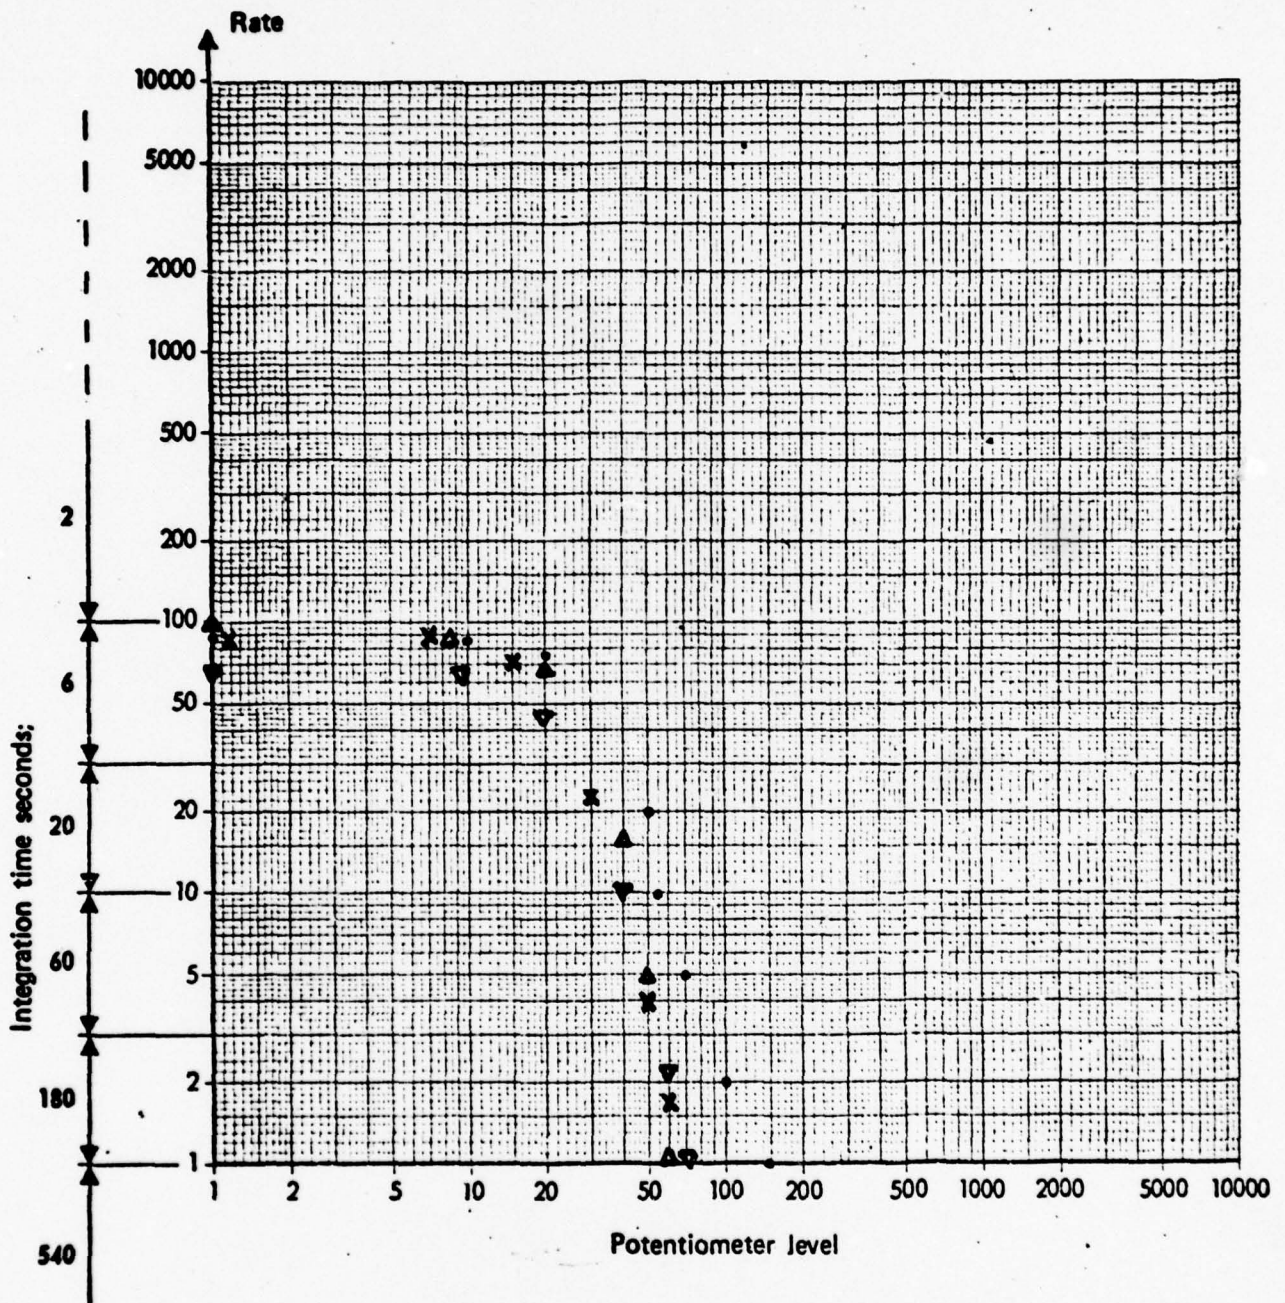
Figure 18 indicates the effect of sensor location on the shock envelope of the mast bearing reading. The accelerometer is normally mounted on the portside. Forward and starboard locations, when compared to the usual mounting exhibit only minor variations; the aft location varies by a factor of two at the higher potentiometer levels.

Effect of Sensor Mounting
 On Mast Bearing Reading

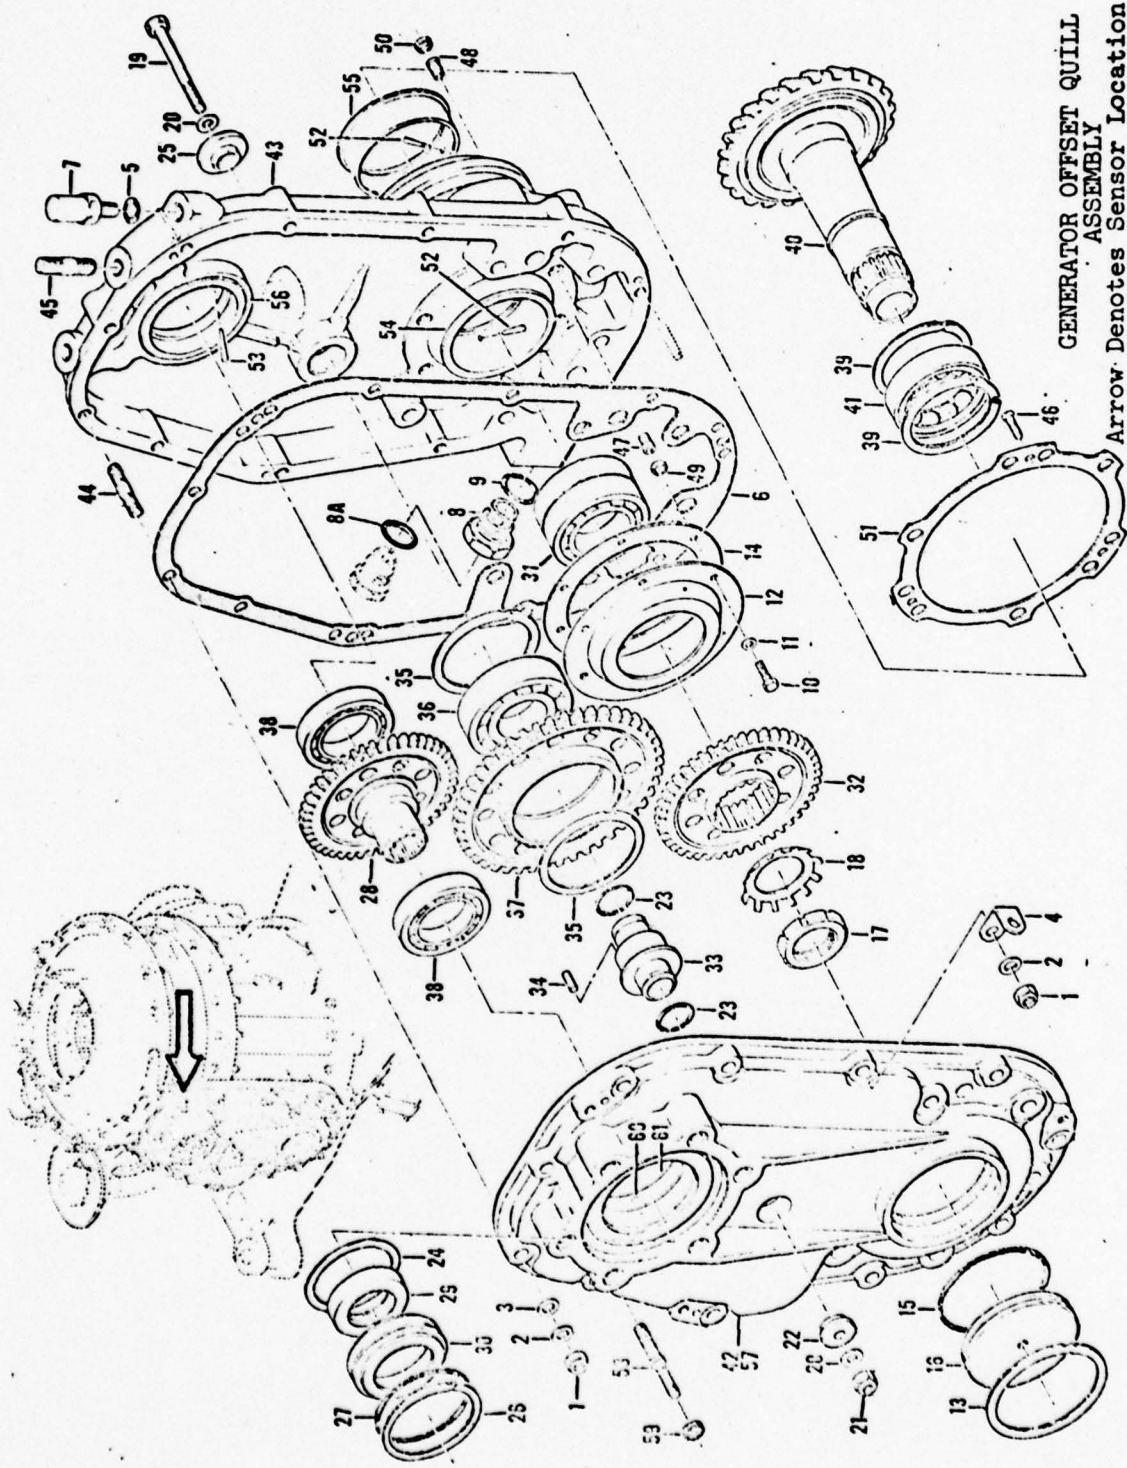
Figure 19

GENERATOR OFFSET QUILL
ASSEMBLY
Arrow Denotes Sensor Location

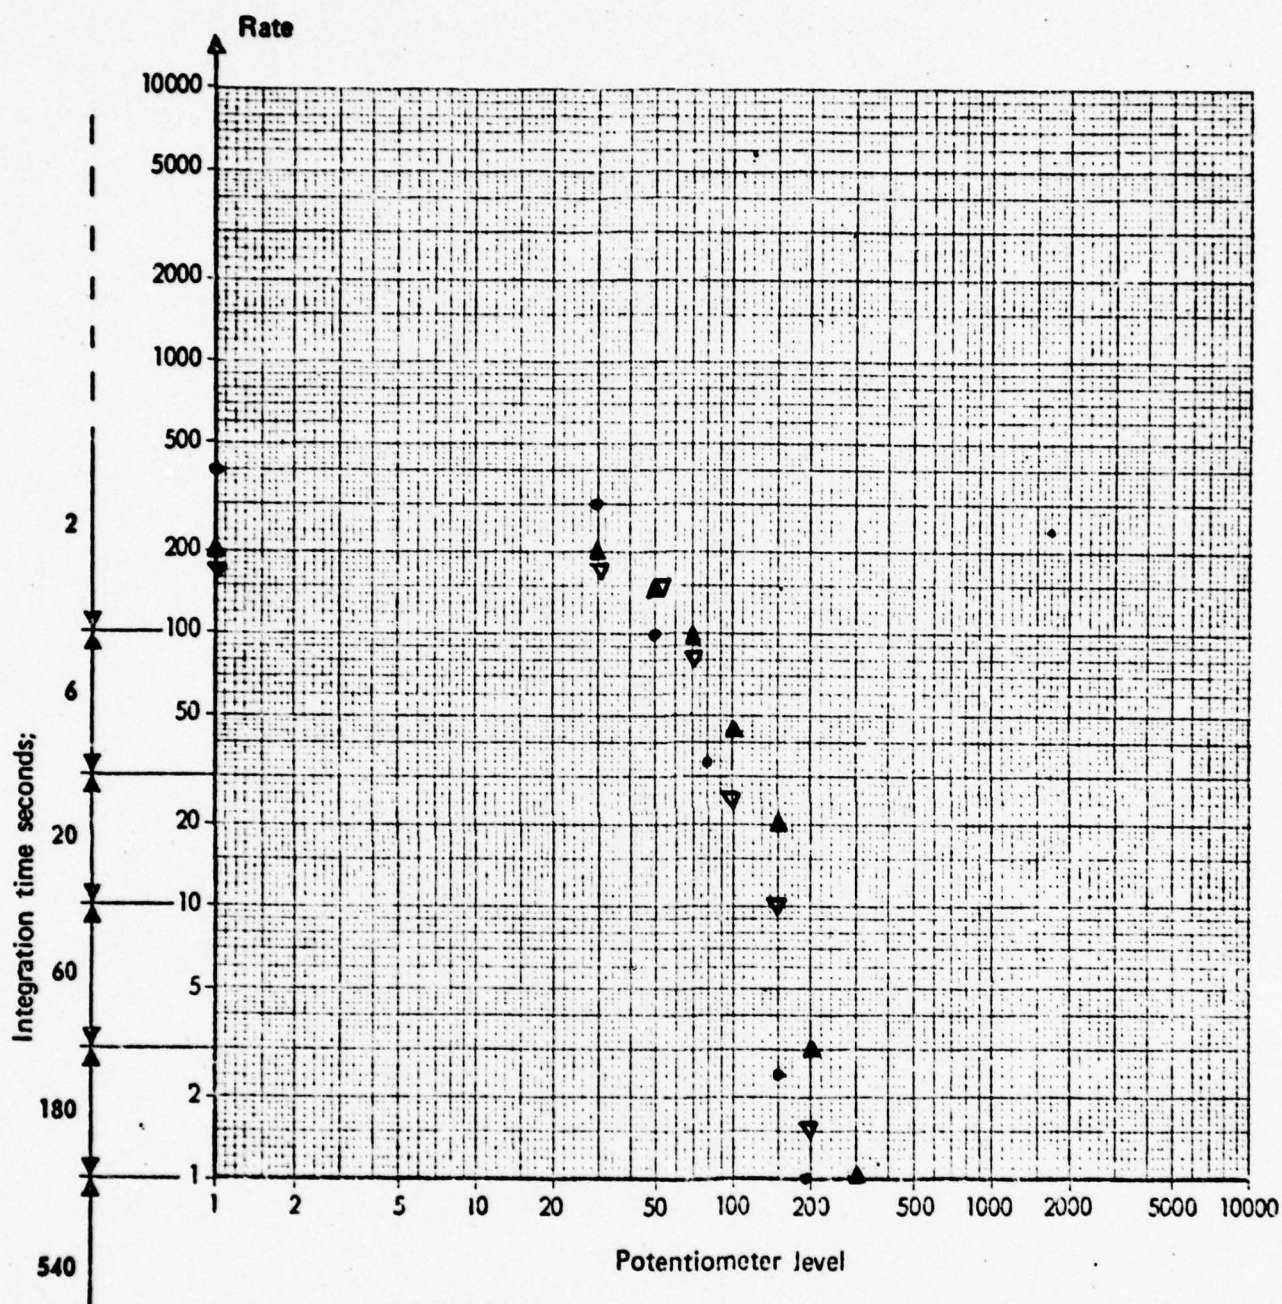
Shock pulse data was collected from the generator offset quill assembly shown in Figure 20 . With the assistance of the Ohio State Research Department, data was recorded on good, as well as implanted, gears in this assembly which was undergoing laboratory tests under an AVLABS contract. Figure 20 shows the shock emission curves for the good and artificially damaged gears. No appreciable difference was noted in the two curves. This could be attributed to an inherent limitation of the MEPA-10 to detect gear damage in this particular assembly, considering: 1) the type of damage artificially implanted; 2) the severity of damage; 3) the contact of the damaged component with other gear elements.

Also shown on Figure 20 is single envelope taken from an assembly as installed on a UH-1H. Although both laboratory and aircraft installed assemblies were operated at approximately the same rpm, there are only minor differences in rate and levels. As these are two different assemblies, with the aircrafts component being of unknown condition, no general conclusions should be inferred.

GENERATOR DRIVE GEAR

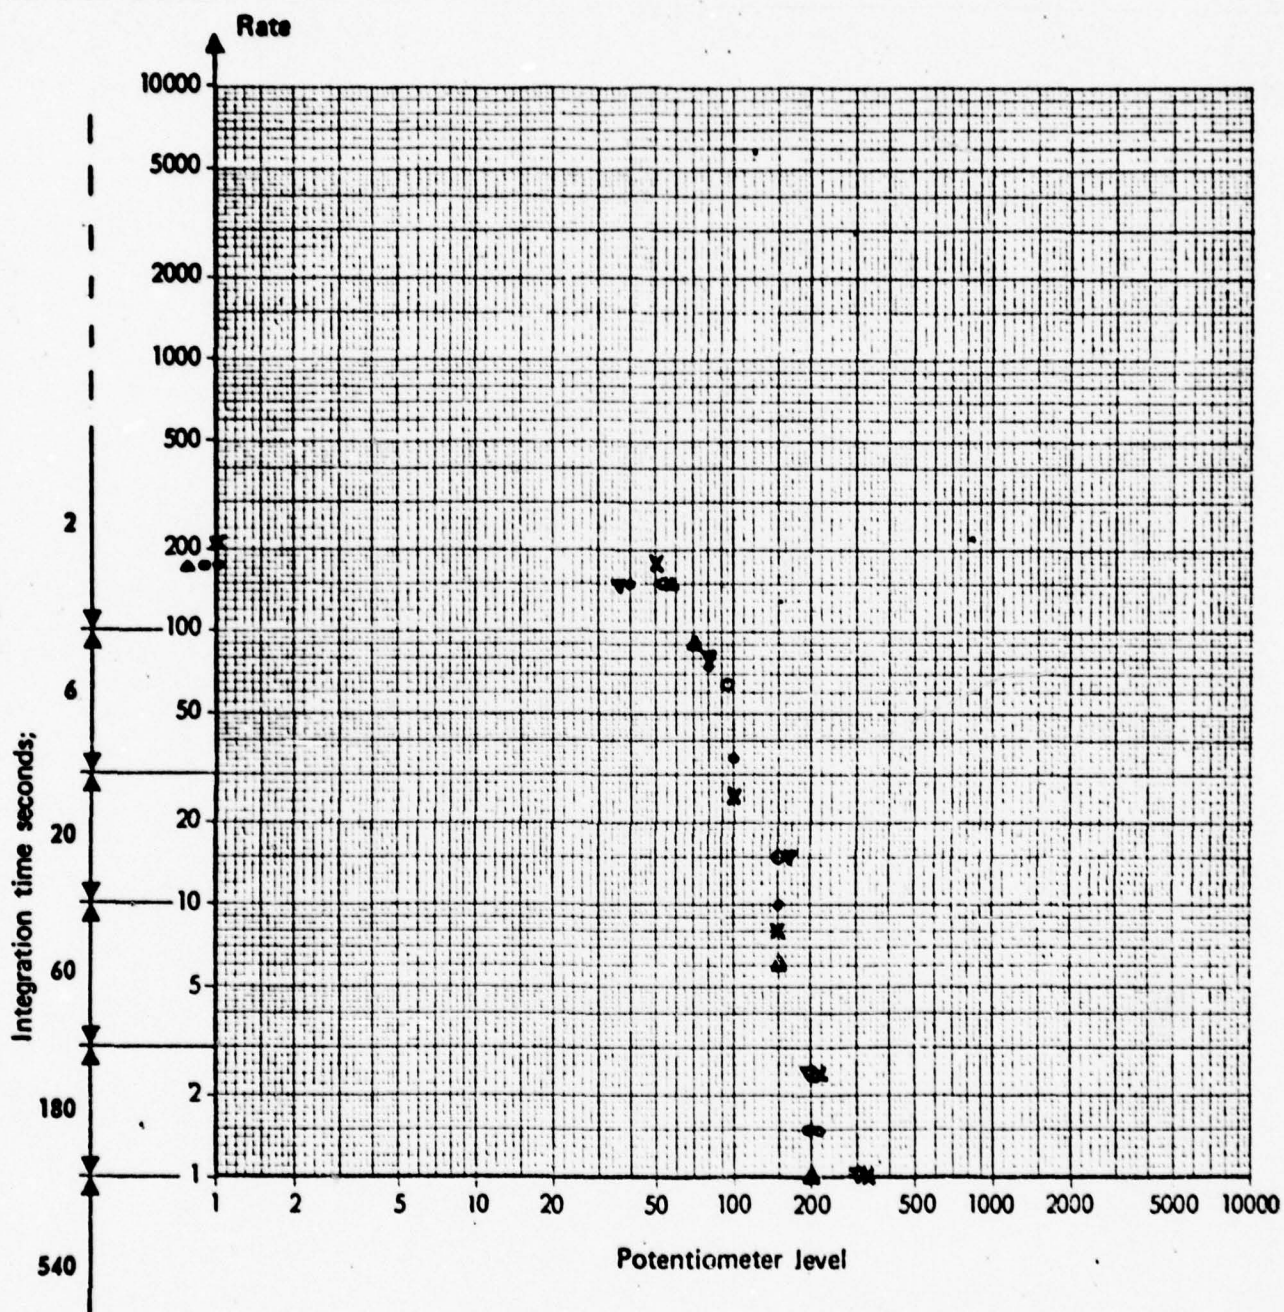
Although not a contractual requirement, data was collected with the shock pulse meter under conditions other than ground runs. Figure 24 shows a comparison of ground, hover-in-ground effect, low and high speed flight, and autorotation conditions. The data was collected with an accelerometer mounted on the input drive quill on UH-1H 69-15550. Figure 25 compares two UH-1H helicopters, both at the same high-speed flight condition. At least as far as the input drive quill is concerned, the various flight conditions had a negligible influence on the shape of the shock emission envelope or on the rate or level readings. The shock emission envelopes fall quite well within the scatter of the bulk of the readings shown in Figure 16. More information will be required before advancing any conclusions as to optimum sensor location or flight profile to record shock pulse signature.

Comparison of Flight and Ground Data
Input Drive Quill, UH-1H S/N 69-15550

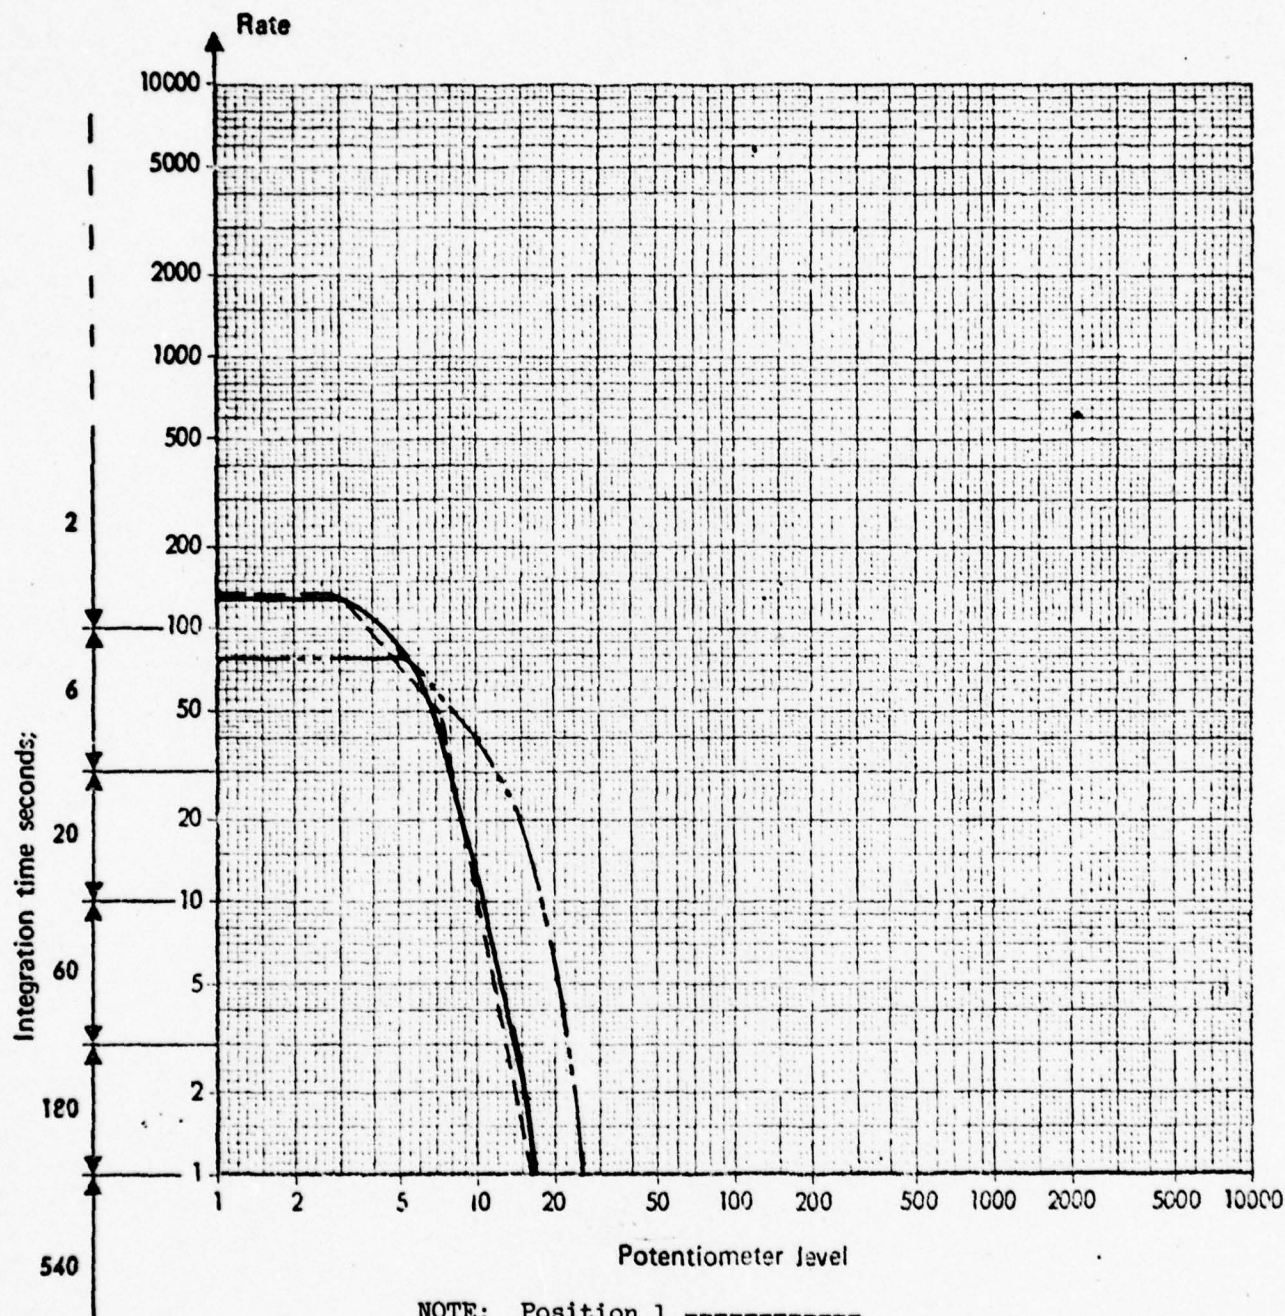
Figure 26

Tests involving a second 42° gearbox with a artificially damaged output quill did not yield repetitive results. Position 1 data, for instance, indicated a high rate of shocks at low shock levels for an implanted gear at low rpm but did not appear at higher rpm. Data from the addition of a damaged input quill unfortunately could not be directly compared as the SKF report did not give the necessary horsepower information. (This will be clarified for the final report.) However, fluctuations were noted in the shock rate data which were of similar nature to that of degraded gearboxes on installed operational helicopters. SKF infers that the fluctuations are due to particulate contaminant in the lubricant and therefore the faulty gear is detected in a secondary manner. Unfortunately when the test data is taken as a whole, this inference appears ambitious.

Mean Profiles- Damaged Gears

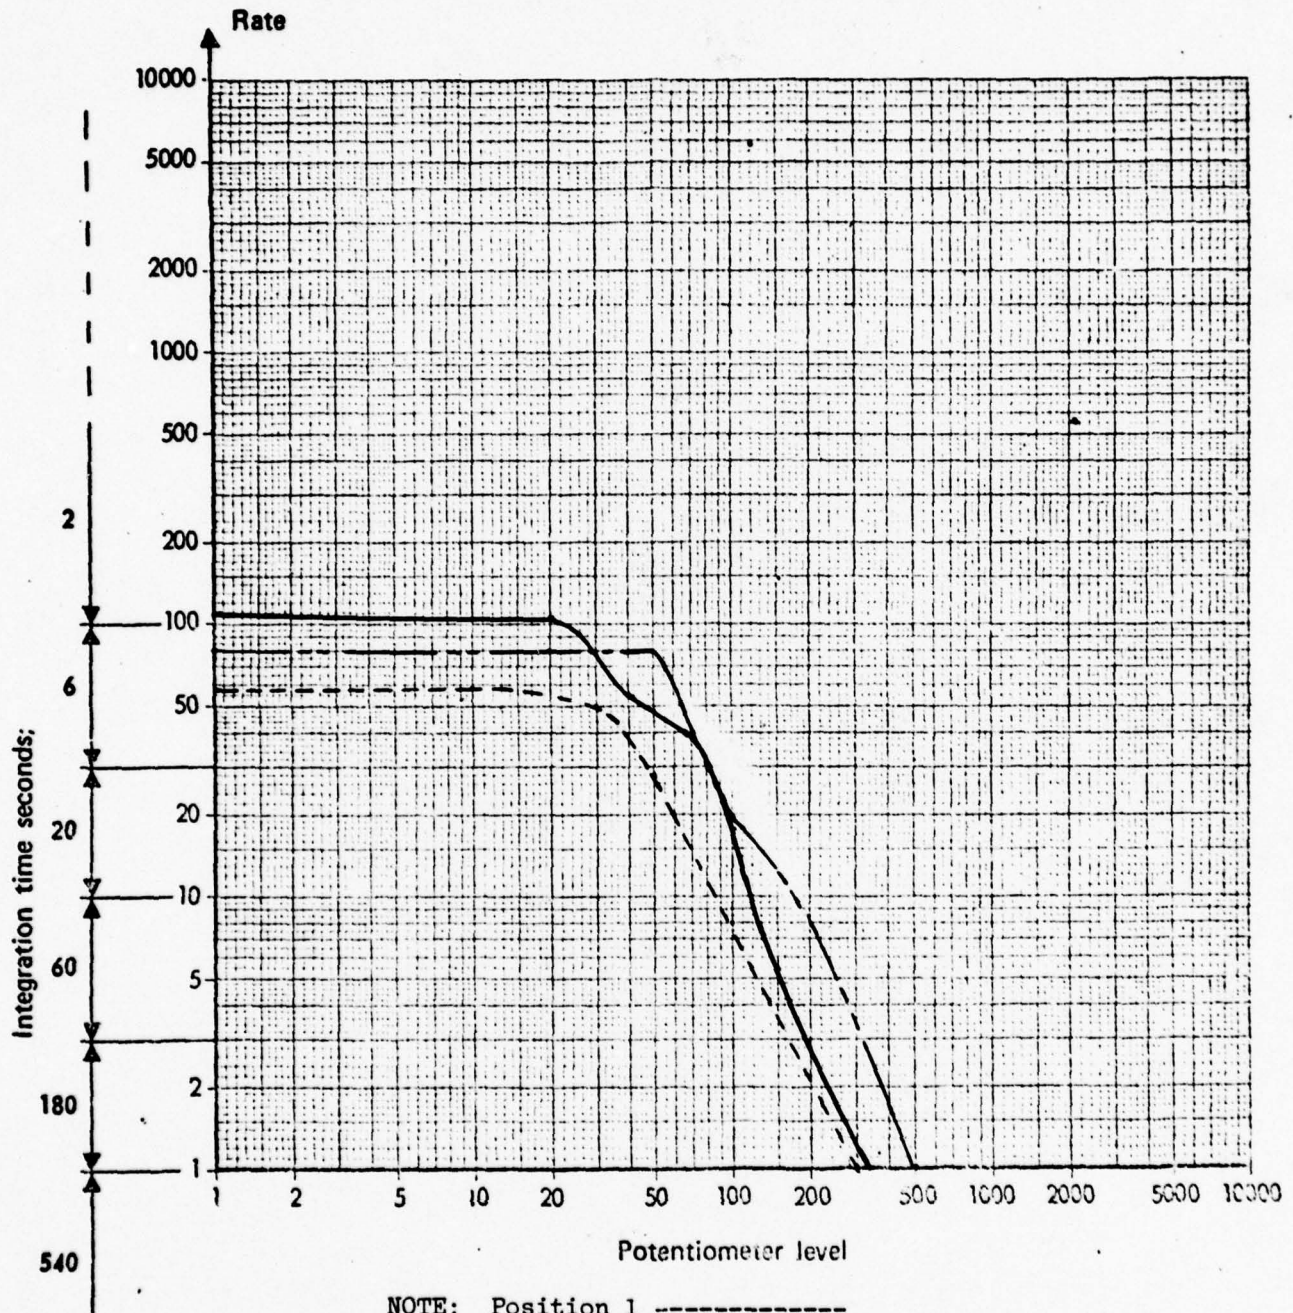
Figure 27

The standard attachment fixture designed by the College was utilized in the final tests and compared to the "optimized" SKF sensor location. The sensor was attached to a bolt on the input quill housing as in its normal use. Inasmuch as fluctuations were noted in the shock pulse curves, mean values were plotted for the two SKF positions and the Parks attachment. Data was taken from Figures 24-29 of Appendix 3.1 and are replotted and compared in Figures 26 and 27. It does not appear that the optimized SKF location is any more sensitive to the degraded gears or bearings than the Parks attachment. Indeed, for the damaged gear, the SKF position 1 location is nearly identical in reading to that of the Parks attachment.

Mean Profiles - Damaged Bearing
